A.8 Case Study: Flood Grouting in Lafayette, LA (2003)

This case study gives details of how flood grouting can be performed to seal mainlines, laterals and manholes. The City of Lafayette wanted to try this method and evaluate if it would be as a cost-effective rehabilitation option for stopping infiltration in the city.

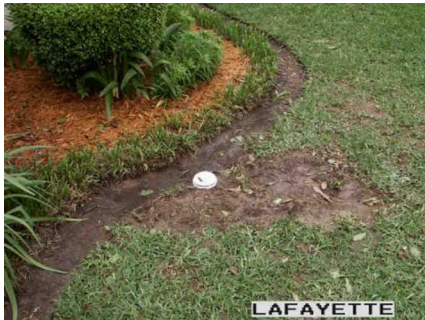
Figure A-91. Newly Installed Cleanout Close to the House.

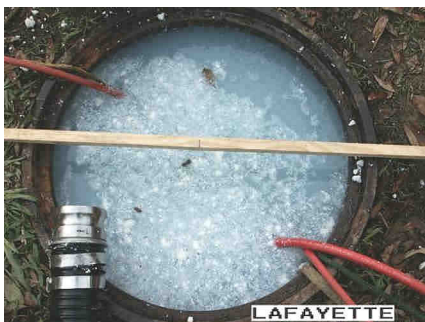
Figure A-99. Manhole Filled with Solution to the Ground Surface.

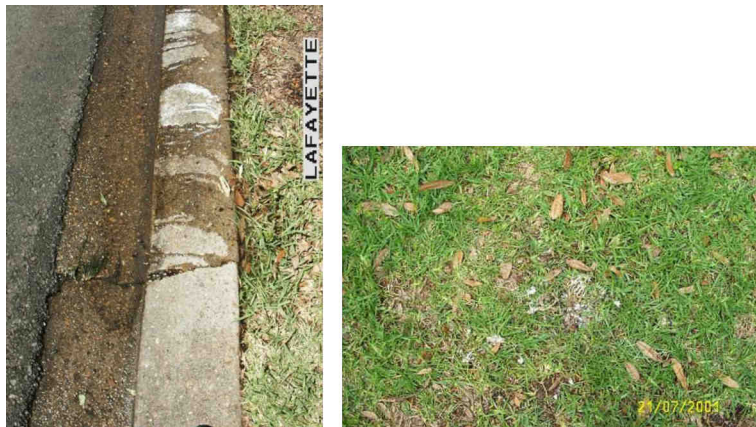
Surface Exfiltration. In several locations, the Sanipor solution reached the surface appearing on the pavement or on the grass (Figure A-100). Surface exfiltration happened because there were channels in the soil (from rainwater draining over time) that extended from rather shallow mainline pipes. These channels were filled and sealed with Sanipor as well. The white stains on the grass show where the Sanipor Silicate gel has formed.

Figure A-100. Left: Exfiltration onto the Pavement (Section #7). Right: Surface Exfiltration onto the Grass (Section #9).

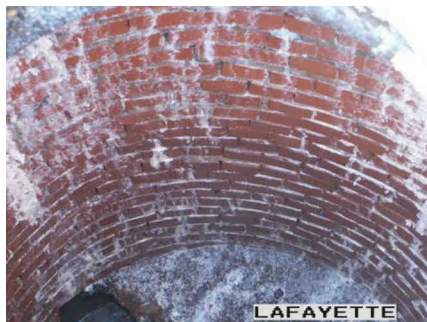
Manhole Sealing. One brick manhole (MH 1252) close to a hydrant was badly leaking whenever the hydrant was opened (section #2). The water was pouring through all gaps between the bricks into the manhole. All gaps in the manhole were successfully sealed with one cycle. White stains in Figure A-101 (MH 1252) show the product of reaction between S-1 (draining from the soil back into the manhole) and S-2 (being filled into the manhole). Five days after the Sanipor sealing, a test was made by opening the nearby hydrant and flooding the surface surrounding the manhole. No infiltration was visible in the manhole anymore.

Figure A-101. Sealed Gaps on the Manhole Wall (Section #2).

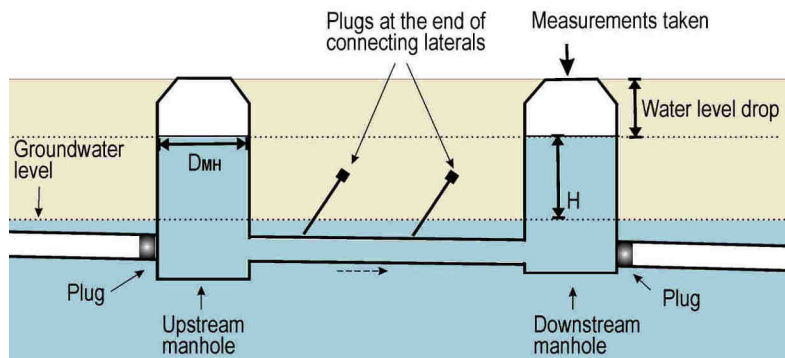
Exfiltration Test “Before”. The water was introduced into the plugged section through the downstream manhole, which was filled to the street level (Figure A-103). The upstream manhole was filled only partially due to the different elevation of manholes and leaking. Because the water level was sinking in both manholes, the lost volume of water was calculated in both manholes and summed⁵⁰. Table A-35 shows the measured drop of the water level in the manhole in the first 8-15 min of filling the sections with the water.

Figure A-103. Water Exfiltration Test “Before”.

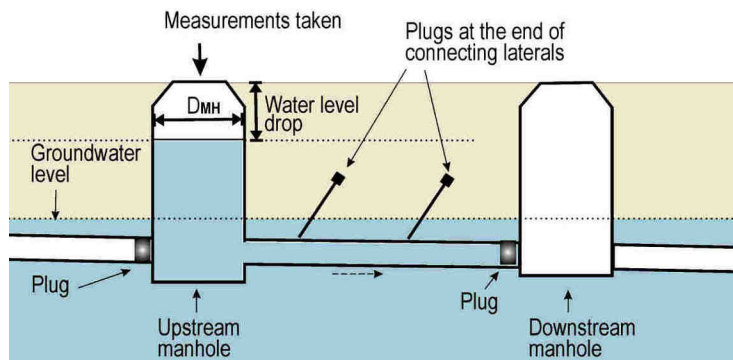
Exfiltration Test “After”. The exfiltration test “after” was performed by measuring the water level drop in the upstream manhole. The downstream manhole was plugged off and remained empty during the sealing (Figure A-104).

Figure A-104. Water Exfiltration Test “After”.

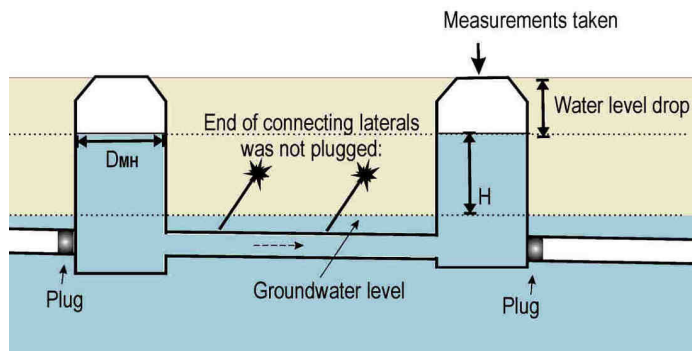
Exfiltration Test 21 Months Later. The test was repeated on 01/18/05, approximately 21 months after the project completion. It was similar to the test "before" having both manholes filled with water⁵³, however the connecting laterals were not plugged at the cleanouts near the houses and the water was able to leak out at those locations (Figure A-107).

Figure A-107. Water Exfiltration Test 21 Months Later.
