A.8 Case Study: Flood Grouting in Lafayette, LA (2003)

This case study gives details of how flood grouting can be performed to seal mainlines, laterals and manholes. The City of Lafayette wanted to try this method and evaluate if it would be as a cost-effective rehabilitation option for stopping infiltration in the city.

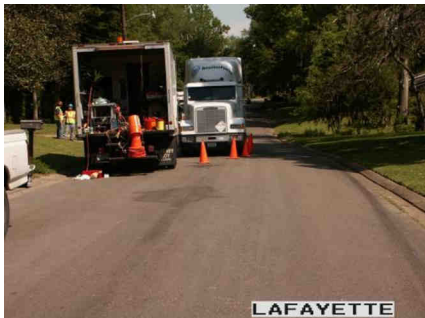
Figure A-92. Typical Site Setup Showing Tanker in the Background and Truck with Equipment in the Front.

Mobilization (Site Setup). To each site, the crew brought the following equipment: a jetting truck, a CCTV truck, buckets for filling the cleanouts with water, pneumatic plugs, a three-chamber tanker with the two solutions (S-1 and S-2), two hoses, and two separate pumps. Figure A-92 shows typical site setup. At the beginning of project, the contractor did not have the proper pumps for a quick and thorough pumping out of the solutions and therefore not all the chemicals could be recovered out of the manhole, which caused serious delays.

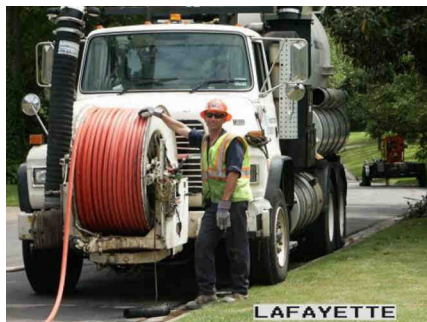
Figure A-93. Jetting Truck.

Cleaning. Manholes and pipes were again cleaned shortly before each start of Sanipor work to insure that the chemicals used for sealing would not be contaminated by the sewage. A 300-gallon trailer flusher was used for water jetting (Figure A-93).

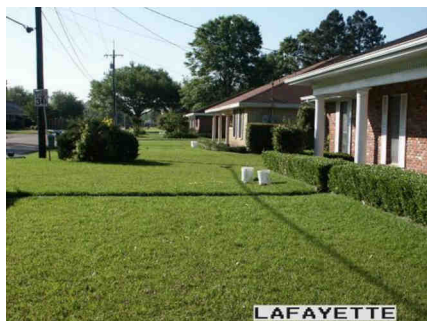
Figure A-94. Buckets Were Used for Adding the Water from a Nearby Hydrant Through the Cleanouts⁴⁷.

Plugging and Initial Water Exfiltration Test. For plugging the lines, 4" and 6" plugs were used in the laterals, and 8" plugs in the mainlines. For the water exfiltration test, the plugged sections were completely flooded to the top of manholes, and the loss of water in 5-minute intervals was measured in the manholes.

The water exfiltration test provided a quantitative order-of-magnitude of the leakage of the chosen section. The amount of exfiltrating water could be compared with the achieved tightness of the pipe system after the Sanipor treatment. Generally, when infiltration is not visible on the CCTV camera, the water exfiltration test is a means of providing reliable data about the leakage in an apparently good sewer system.

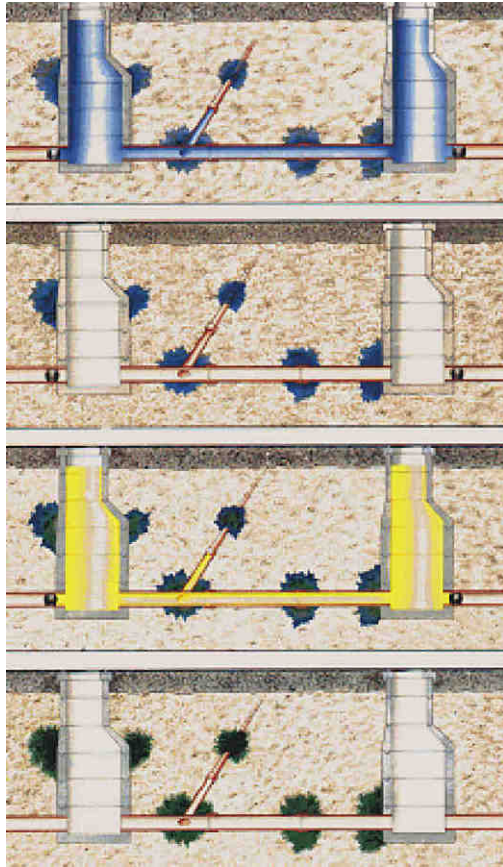
Figure A-95. Four Steps in Flood Grouting Procedure.

Flooding with Two Sanipor[®] Solutions. After plugging the sections, the Sanipor process was performed in four steps (Figure A-95).

- ◆ The section was completely filled with the solution S-1 from its tanker, i.e. the liquid level in the manhole was brought up to the street level. This created the necessary hydrostatic head for the injection of S-1 through the defects into the soil. While the level of S-1 was gradually sinking, the liquid was being refilled (once or several times) up to street level in order to maintain the hydrostatic head required for exfiltration.
- ◆ After a certain time, S-1 was pumped out completely and all pipes flushed with water (the laterals were flushed with the help of buckets and the mainline with a quick interim flush of water with the jetting truck).
- ◆ Next, the section was completely filled with the solution S-2 from its tanker in the same manner as previously with the solution S-1. In the soil, two components reacted with each

other and the soil particles, stabilizing the soil and creating a watertight isolation layer around the leaks.

- ◆ After a certain time, S-2 was pumped out completely and all pipes flushed with water.

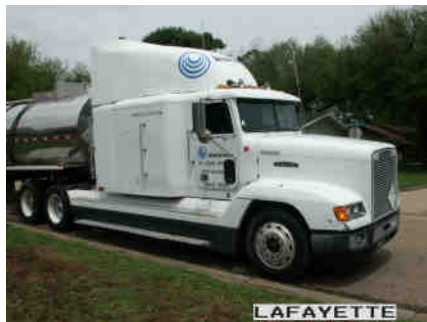
Figure A-96. Three-chamber Tanker for Transporting the Chemicals.

A three-chamber tanker was used to transport S-1 and S-2 to site (Figure A-96). Each chemical component had its own hose in order to avoid mixing and polluting S-1 and S-2 with each other (Figure A-97).

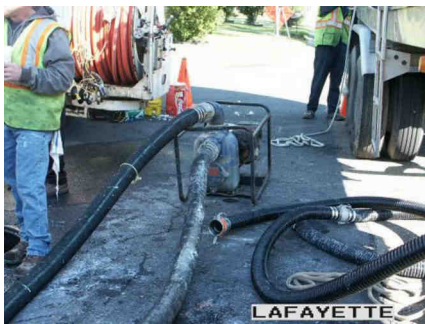
Figure A-98. Pumps.

Strong and reliable pumps have a very important role in the Sanipor technology (Figure A-98). Having no vacuum pumps on the tankers, two separate pumps were used to pump out the large volumes of the sealing liquids from the sewer sections/manholes (circa 2,000-3,000 gal each).

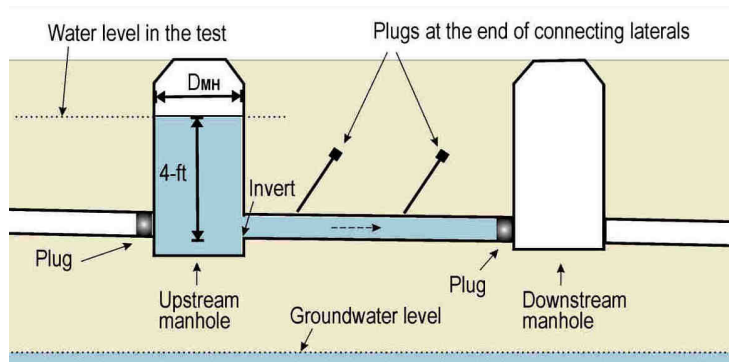
Figure A-105. Greenbook Water Exfiltration Test.

Allowable Leakage Rates. One standard that regulates in-situ tests of the required leak-tightness in sewers⁵² is the Greenbook SSPWC 306-1.4. According to this standard, the section in a water exfiltration test has to be filled to a point 4' above the invert of the pipe at the center of the upstream manhole, or a minimum of 4' above the average groundwater level (Figure A-105). The allowable leakage is calculated as follows:

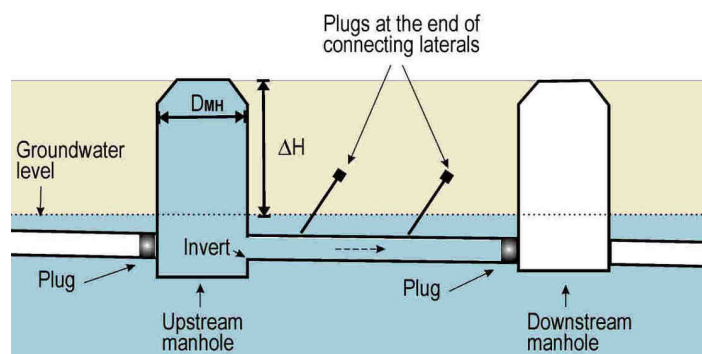
Figure A-106. Allowable Leakage Rates in Sanipor Water Exfiltration Tests.

The allowable leakage rate in the Sanipor sealing tests was calculated using formula (4), where ΔH was assumed to be 5' (Figure A-106). The groundwater level in Lafayette is usually deep, however, the project was performed shortly after heavy rains and the groundwater level was approximately at 5' depth. Table A-37 shows the calculated rates that should be allowable in the tests compared with earlier determined rates.
